Name Of Dam: POWELL

Location: CITY OF SOUTH BOSTON.

Inventory Number: VA 08336

## PHASE I INSPECTION REPORT NATIONAL DAM SAFETY PROGRAM

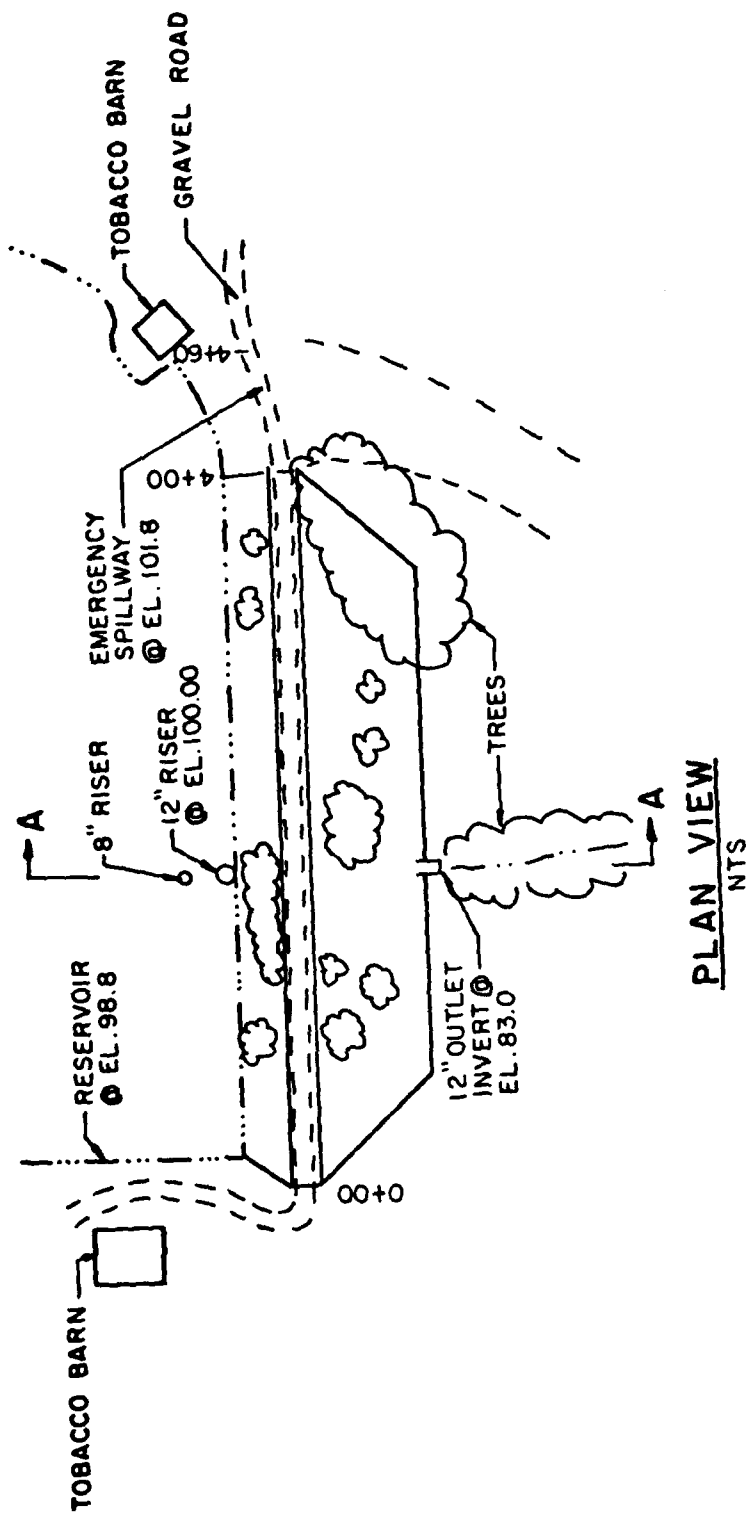
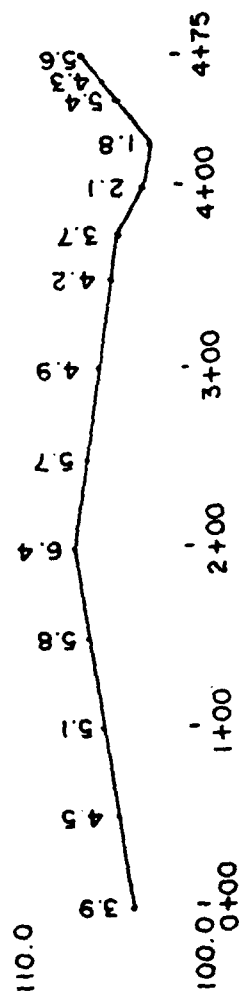
PLATE II

3.1.2 Embankment: The embankment is in good condition. A dirt and gravel roadway traverse the crest of the dam. A sketch showing a plan view and crest profile is provided on Plate II, Appendix I. A cross section is given on Plate III, Appendix I. Overall views of the dam are provided at the beginning of the report.

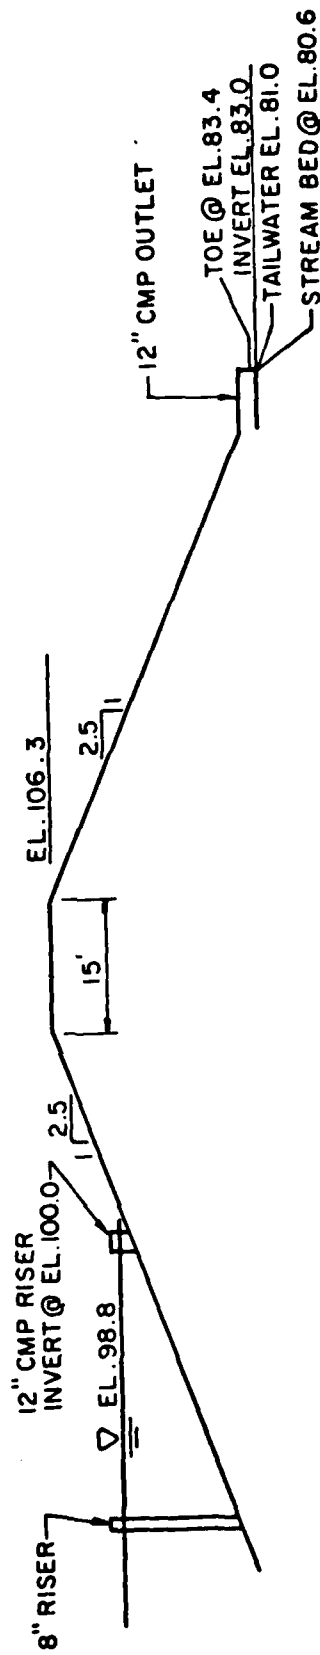
CROSS SECTION A-A  
NTS

According to the guidelines presented in Design of Small Dam, U. S. Department of the Interior, Bureau of Reclamation, the slopes recommended for a homogeneous small dam of similar material not subjected to a rapid drawdown are 3H:1V upstream and 2.5H:1V downstream. The recommended crest width is 15 feet. Based on these guidelines, the Powell Dam has an adequate downstream slope and crest width, and an inadequate upstream slope.
